28th November 2016

Anstey & Stone Ltd

Havant Road Milestone Report.

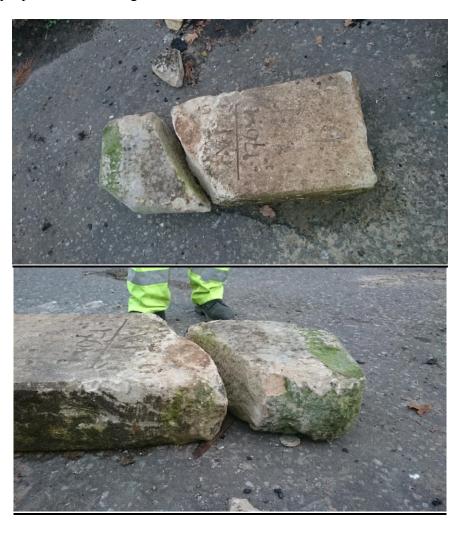
In viewing the milestone first hand it is clear that the damage is substantial. There has obviously been quite great deal for erosion and weather damage. This is mainly caused by its location and the placement of iron plate on the back of the marker as shown in photos DSC_0559 and DSC_0560 below. A large proportion of the original stone has been lost.

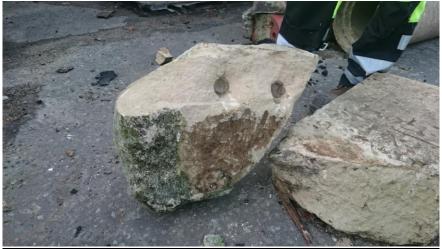
The separated top section has also sustained impact damage down one side (DSC_0562 below)

rendering it irreparable.

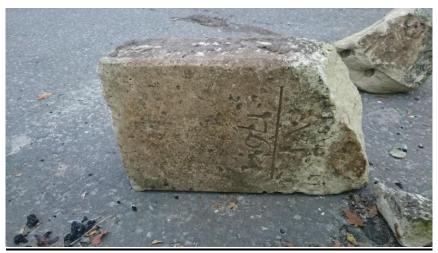
The bottom section of the stone is in fairly good condition from being buried but the break runs very close and at an angle to the original carved lettering and therefore renders it really unusable.

We have determined that it is most likely a source of Purbeck stone, a type of hard limestone. It is not a commonly used stone in this size anymore but might be able to be sourced or a similar equivalent could be used to replace it.
